Old Salina Landfill

POTENTIAL HAZARDOUS MASTE SITE PRELIMINARY ASSESSMENT PART 1 - SITE LOCATION AND INSPECTION INFORMATION

Section	
1	Site Inspection Report Executive Summary
2	Environmental Protection Agency Form 2070-13
3	Maps and Photographs
4	Documentation Records for Hazard Ranking System
5	Hazard Ranking System Scoring Forms
6	Bibliography of Information Sources
7	Press Release Summary - MITRE Hazard Ranking System
8	Attachments - Cited Documents

POTENTIAL HAZARDOUS WASTE SITE SITE INSPECTION REPORT EXECUTIVE SUMMARY

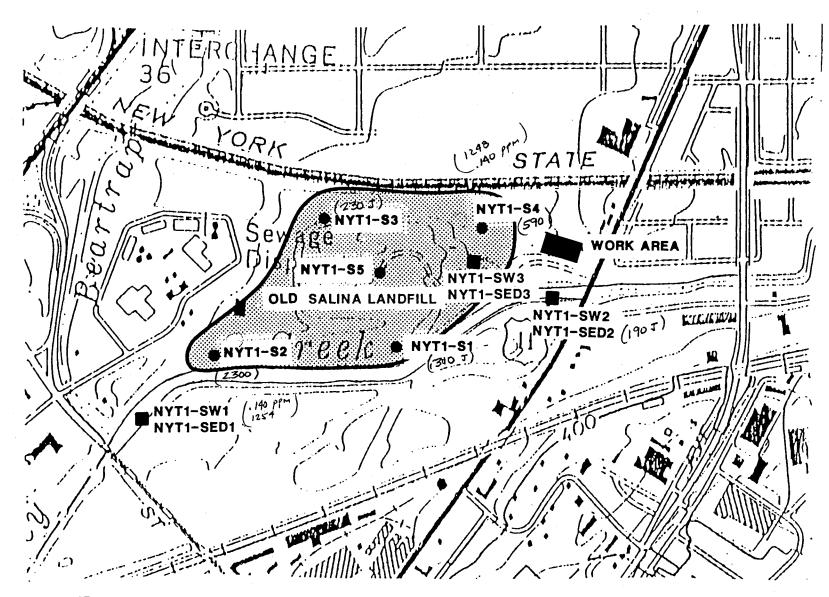
Figure 1 Provides a Site Location Map Figure 2 Provides a Sample Location Map Exhibit A Provides Site Photographs

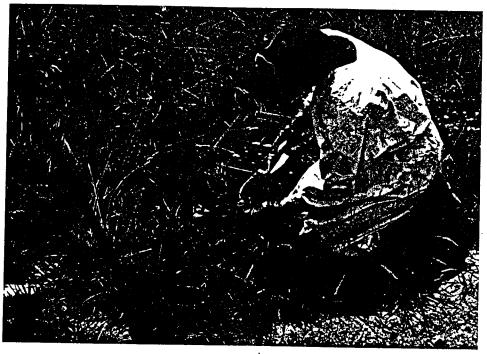
July 1, 1986 1230 Collecting sample NYT1-S1.

Location: Southeast corner of landfill. Samplers: Pete Morton, Laurie Gneiding. Photographer: Salvador A. Riggi Jr.

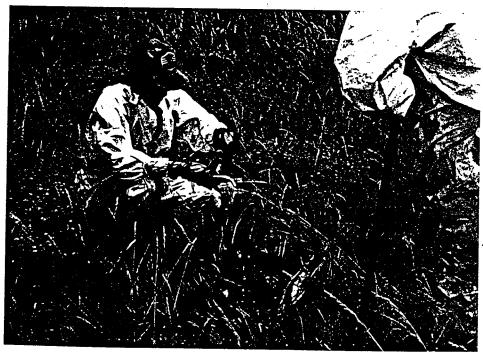
1P-2 July 1, 1986 1245 Collecting sample NYT1-S2.

Location: Southwest corner of landfill.
Samplers: Pete Morton, Laurie Gneiding.
Photographer: Salvador A. Riggi Jr.

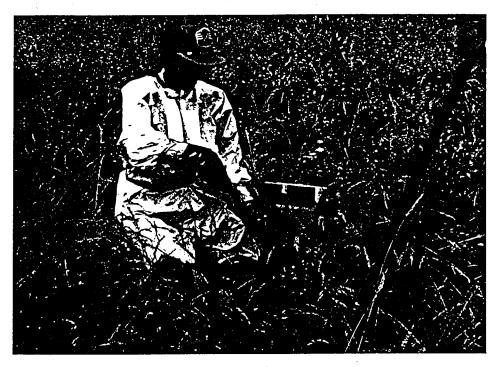
1P-3 July 1, 1986 1250

Collecting sample NYT1-S3.

Location: Northwest corner of landfill. Samplers: Pete Morton, Laurie Gneiding. Photographer: Salvador A. Riggi Jr.

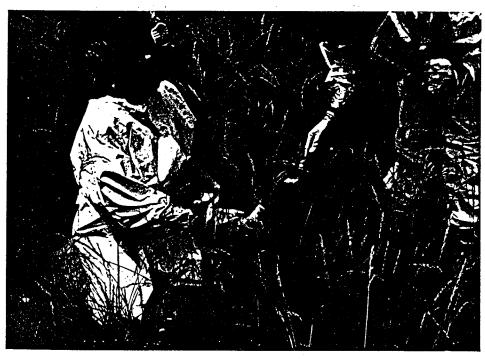
1P-4 July 1, 1986 1320

Collecting sample NYT1-S4.

Location: Northwest corner of landfill. Samplers: Pete Morton, Laurie Gneiding. Photographer: Salvador A. Riggi Jr.

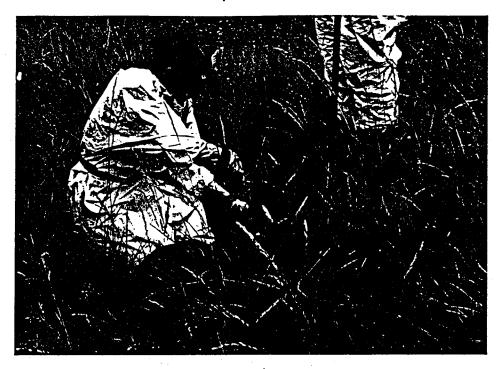
1P-5 July 1, 1986 1325 Collecting sample NYT1-S5.

Location: Center of landfill.

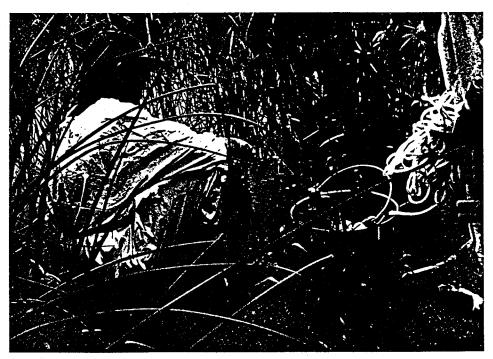
1P-6 July 1, 1986 1353

Collecting sample NYT1-SW1.
Location: Downgradient, Ley Creek.
Samplers: Laurie Gneiding, Pete Morton.
Photographer: Salvador A. Riggi Jr.

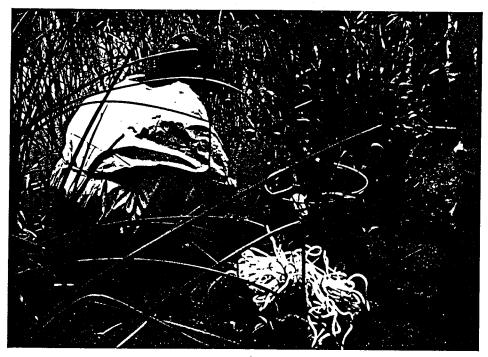
1P-7 July 1, 1986 1400
Collecting sample NYT1-SED1.
Location: Same as NYT1-SW1.
Samplers: Laurie Gneiding, Pete Morton.
Photographer: Salvador A. Riggi Jr.

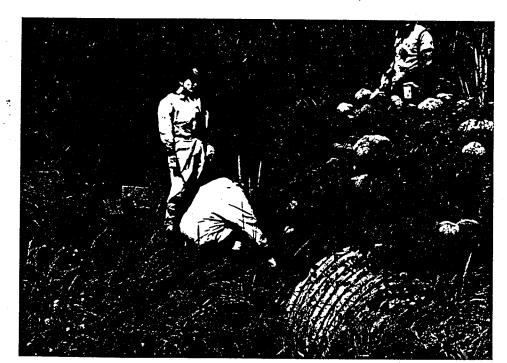
1P-8 July 1, 1986 1425 Collecting sample NYT1-SW3.

Location: Northeast drainage ditch approximately 50 feet west of

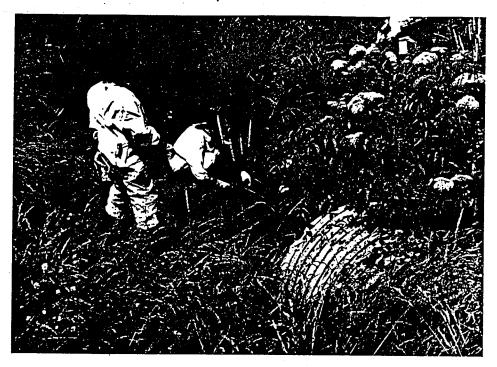
1P-9 July 1, 1986 1430
Collecting sample NYT1-SED3.
Location: Same as NYT1-SW3.
Samplers: Pete Morton, Laurie Gneiding.
Photographer: Salvador A. Riggi Jr.

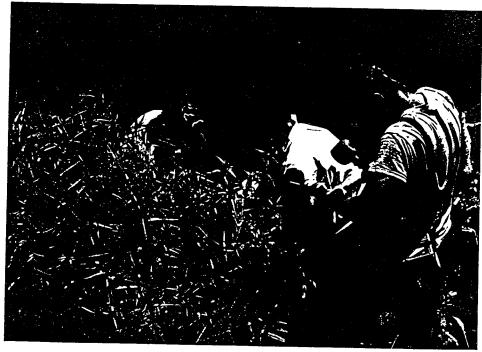
1P-10 July 1, 1986 1440
Collecting sample NYT1-SW2.
Location: Upgradient, Ley Creek.
Samplers: Laurie Gneiding, Pete Morton.
Photographer: Salvador A. Riggi Jr.

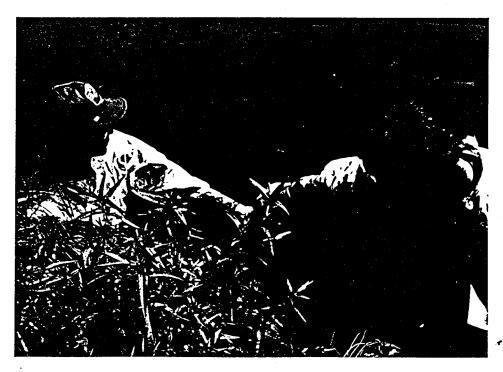
1450 July 1, 1986 1P-11 Collecting sample NYT1-SED2.
Location: Same as NYT1-SW2.
Samplers: Laurie Gneiding, Pete Morton.
